Arc flash suit visual inspection

This document is intended to provide a guideline on how to perform a visual inspection of a Bussmann™ series arc flash suit, including the coat, bib overalls, hood and ventilation system.

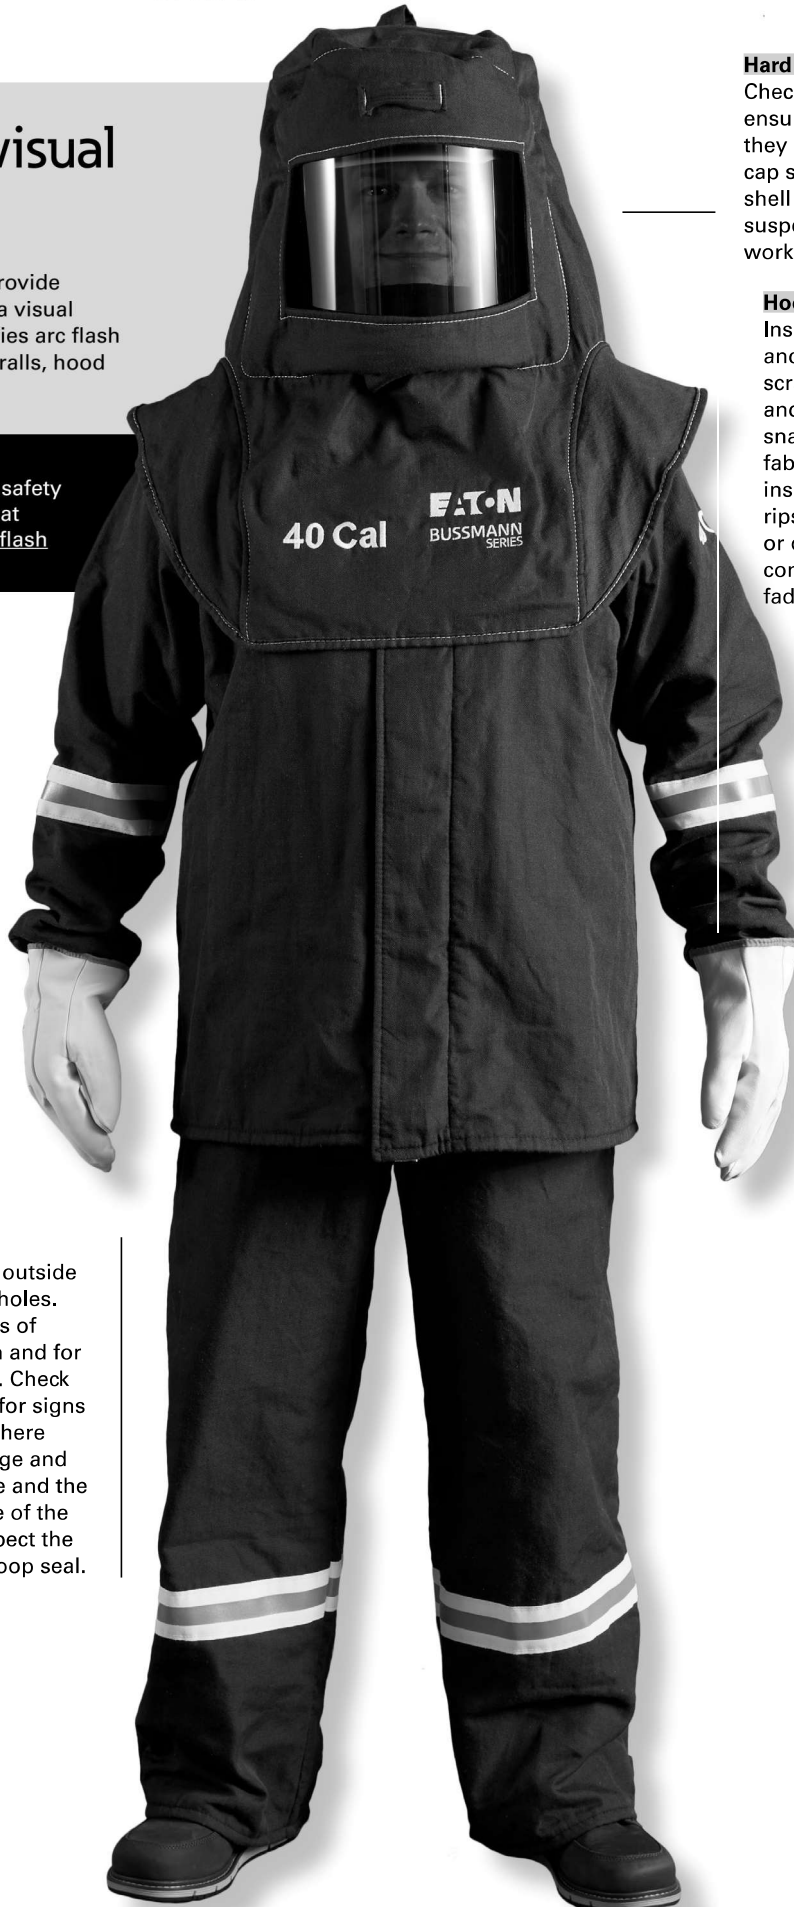
Suit pictured is the Bussmann series 40 calorie comfort arc flash suit. View our entire collection of arc flash suits and accessories [HERE](#).

Ensure the fabric inside and outside does not have rips, tears or holes. Look for stains or other types of damage from contamination and for excessive fading of material. Check the zipper and/or hook and loop closure to confirm there are no visible signs of damage.

Ensure the fabric inside and outside does not have rips, tears or holes. Look for stains or other types of damage from contamination and for excessive fading of material. Check the suspenders and inspect for signs of excessive wear. Confirm there are no visible signs of damage and that the buckles are operable and the suspender strap is flat inside of the adjustment mechanism. Inspect the cinch strap(s) for hook and loop seal.

Check the shield adapters and ensure there are no cracks and that they are correctly fitted inside the cap side slots. Inspect for cracks, shell expiration date and that the suspension adjusting mechanism works.

Inspect the hood window inside and outside, looking for excessive scratching, cracks or other damage and replace if necessary. Ensure the snaps are securely attached to the fabric and shield, and that the fabric inside and outside does not have rips, tears or holes. Look for stains or other types of damage from contamination and for excessive fading of material.

Perform a system check by turning the fan on. Replace the batteries if needed. Check the fan connection to coupling and ensure it is fully engaged into a locked position. Ensure the fan unit is fully secured inside the pocket, loop or strap (located at back).
